November 2012 Volume 6 Issue 9

From Rockets to Ruins

The PEPCON Ammonium Perchlorate Plant Explosion

SYSTEM FAILURE CASE STUDY

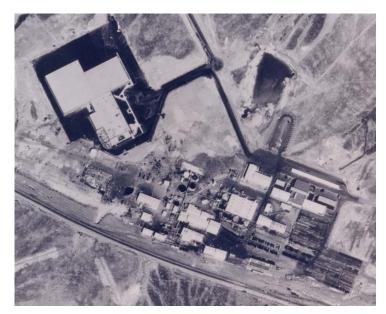
Figure 1. The PEPCON facility before the blasts. Source: Lawrence Livermore National Laboratory.

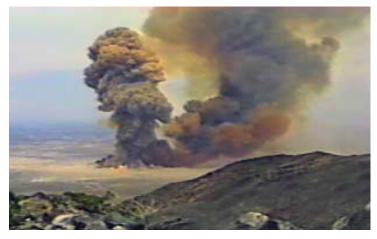
Figure 3. It is estimated that the second major explosion consumed 1,500 tons of AP—almost four times the ammount of AP consumed by one Space Shuttle Solid Rocket Booster. Source: Public Domain

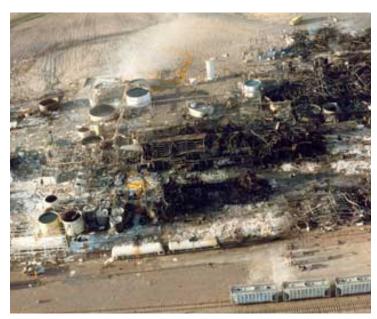
The PEPCON facility and neighboring Kidd Marshmallow plant were completely obliterated. The shockwaves had damaged buildings in Henderson; shattering windows, cracking walls, and breaking doors. The affected area spanned a 10-mile radius from the PEPCON facility.

Figure 5. Remnants of the PEPCON facility. Source: Lawrence Livermore National Laboratory.
